ON-SITE AIR BAG NON-DEPLOYMENT INVESTIGATION

CASE NUMBER - IN-06-033

LOCATION - WISCONSIN

VEHICLE - 2005 CHEVROLET COBALT

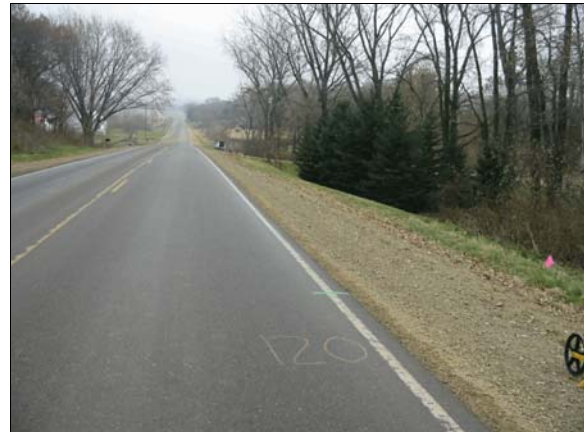
Figure 1: Approach of case vehicle eastbound to roadway departure, number on roadway indicates meters to impact

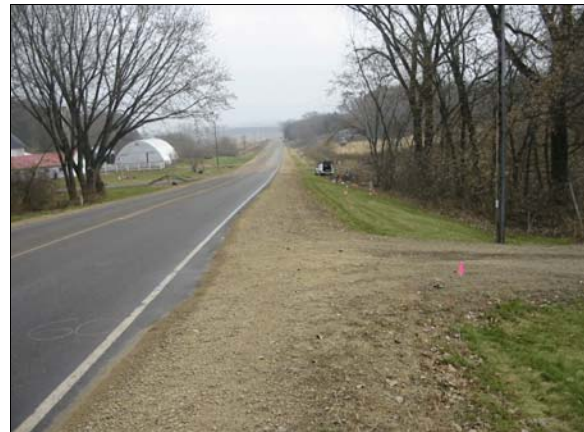
Figure 2: Overview of path of case vehicle, flag at edge of driveway shows track of case vehicle's left side tires

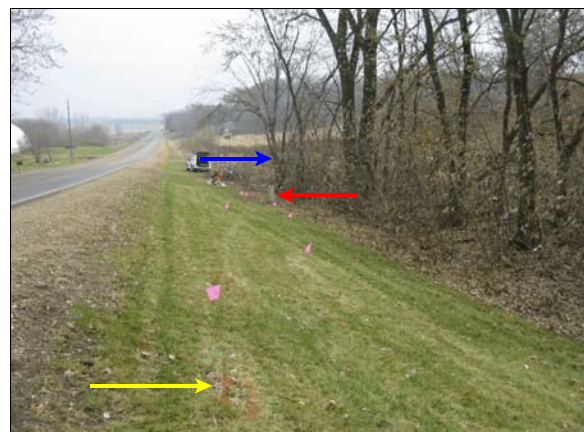
Figure 3: Vehicle touchdown location (yellow arrow) from vault and approach to telephone utility box impact (red arrow) and impact with clump of trees (blue arrow)

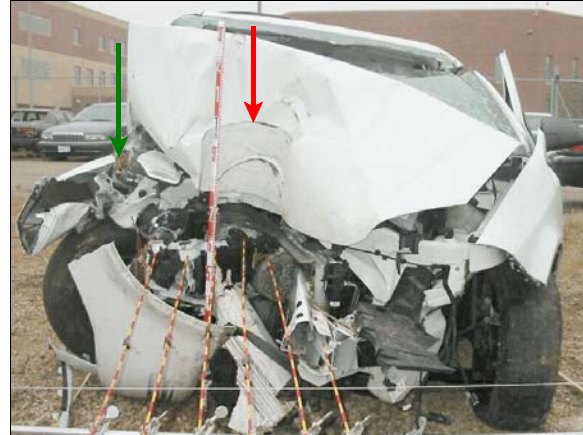
The center right of the case vehicle initially engaged the leading tree in the clump and then the front right engaged a tree immediately behind and to the right of the first tree (**Figures 4 and 5**). The first tree was displaced in the ground and broken off at the root. It appeared that a branch from this tree also broke off and impacted the top of the case vehicle and broke out the backlight (event 3). The case vehicle's driver and front right air bags did not deploy as a result of the impact with the clump of trees, possibly due to the yielding nature of the impact with the first tree or power loss due to movement of the ignition switch just prior to the impact. See the discussion below under the "**Case Vehicle**" and "**Crash Data Recording**" sections for further information regarding the ignition switch problem and air bag non-deployment.

Figure 4: Damage to case vehicle from impact with clump of trees, red arrow shows impact location of tree that broke off, green arrow shows impact location of second tree, vertical scale in tenths of meter

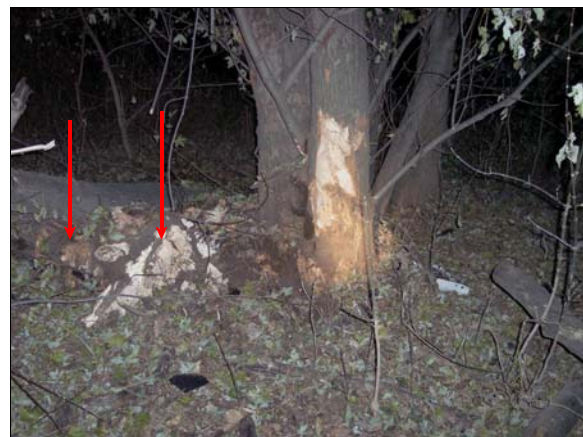
Figure 5: Police on-scene photo of impacted clump of trees, arrows shows broken/uprooted tree

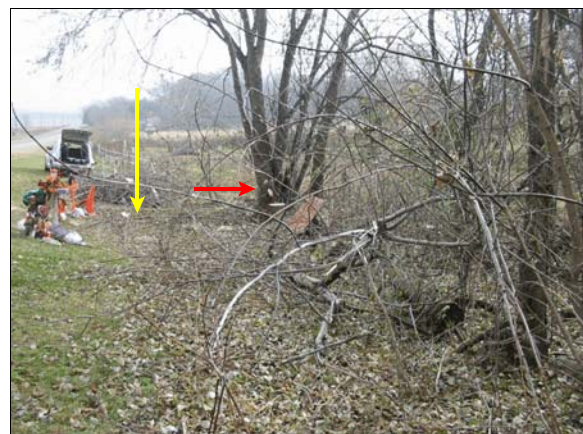
Post-Crash: As a result of the tree impact, the case vehicle rotated clockwise approximately 90 degrees and came to rest heading southwest (**Figure 6**). At final rest the case vehicle was approximately 3 meters (10 feet) north of the impacted clump of trees.

Figure 6: Red arrow shows impacted clump of trees, yellow arrow shows area of case vehicle's final rest

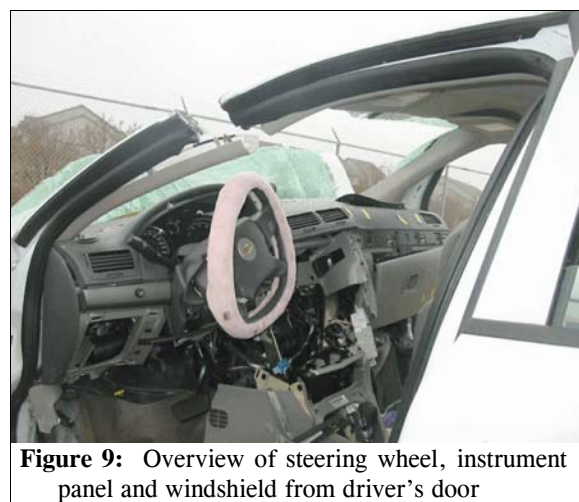
Vehicle Interior: Inspection of the case vehicle's interior (**Figure 9** and **Figures 10** and **11** below) revealed that primarily the right half of the steering wheel was severely bent forward and the steering column was crushed forward and upward (**Figure 12** below) due to driver loading. The driver's knee bolsters had been heavily contacted by the driver's knees and broken out. There were scuff marks on the right instrument panel and the glove box door due to loading by the front right passenger. The front right passenger's seat back was also intruded forward nearly to the instrument panel (**Figure 10** below) due to loading by the unrestrained back right passenger. Passenger compartment intrusion involved the driver's and front right passenger's toe pans, which intruded longitudinally 18 centimeters (7.1 inches) and 23

Figure 9: Overview of steering wheel, instrument panel and windshield from driver's door

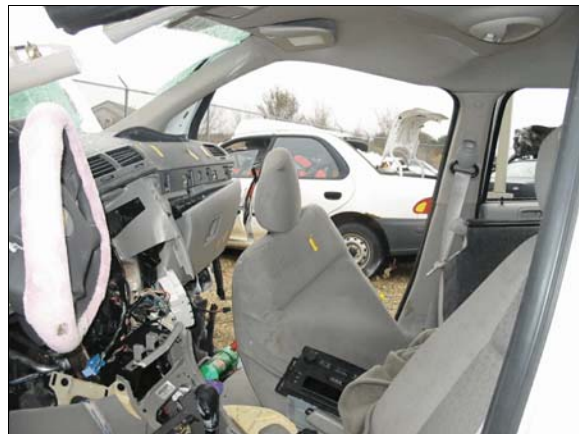
Figure 10: Left side view of steering wheel, instrument panel and displacement of front right seat back and head restraint due to the back right passenger loading the seat back into the front right passenger

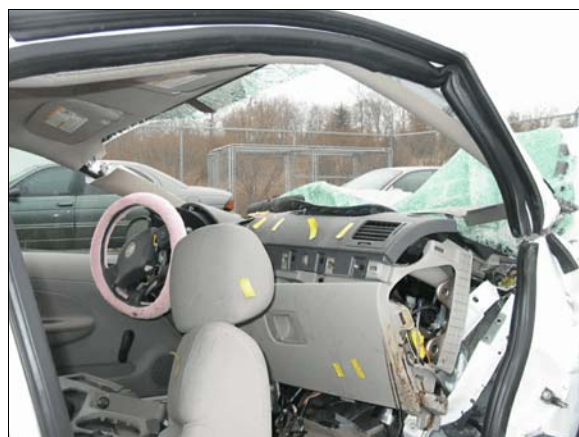
Figure 11: Right side view of case vehicle's front seating row, instrument panel, steering wheel and windshield

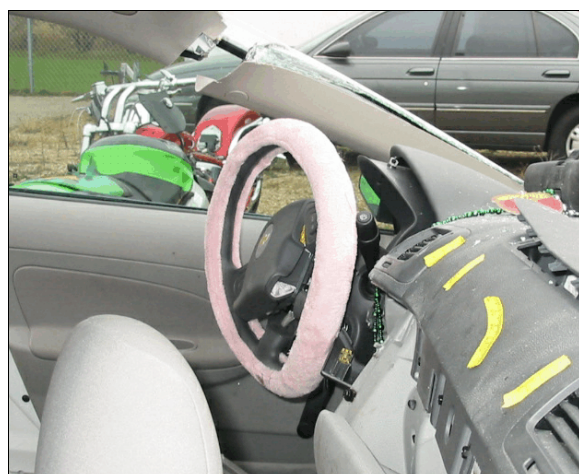
Figure 12: Right side view of deformation to steering wheel and steering column

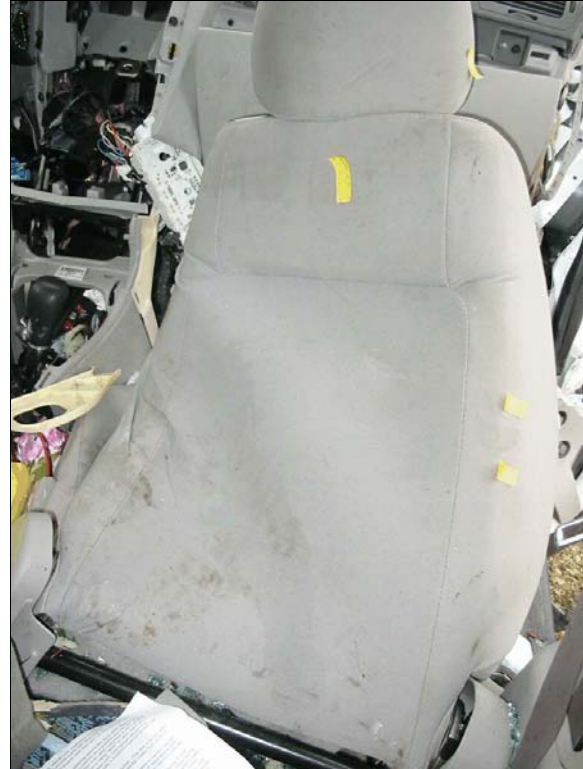
seat back extensively forward (**Figure 13**). The back right passenger most likely ramped over the seat back and impacted her head on the windshield header causing facial fractures and a traumatic brain injury. The back right passenger rebounded and as the case vehicle rotated clockwise, she most likely contacted the right rear door. She was found lying face up across the back seat with her feet in the floor pan behind the driver's seat. She was removed from the case vehicle by rescue personnel.

Figure 13: Damage to front right passenger's seat back due to loading by unrestrained back right passenger
